Normal people in normal organizations :FRAM analysis of a mid-air collision

Paulo V. R. Carvalho – IEN/CNEN

The collision

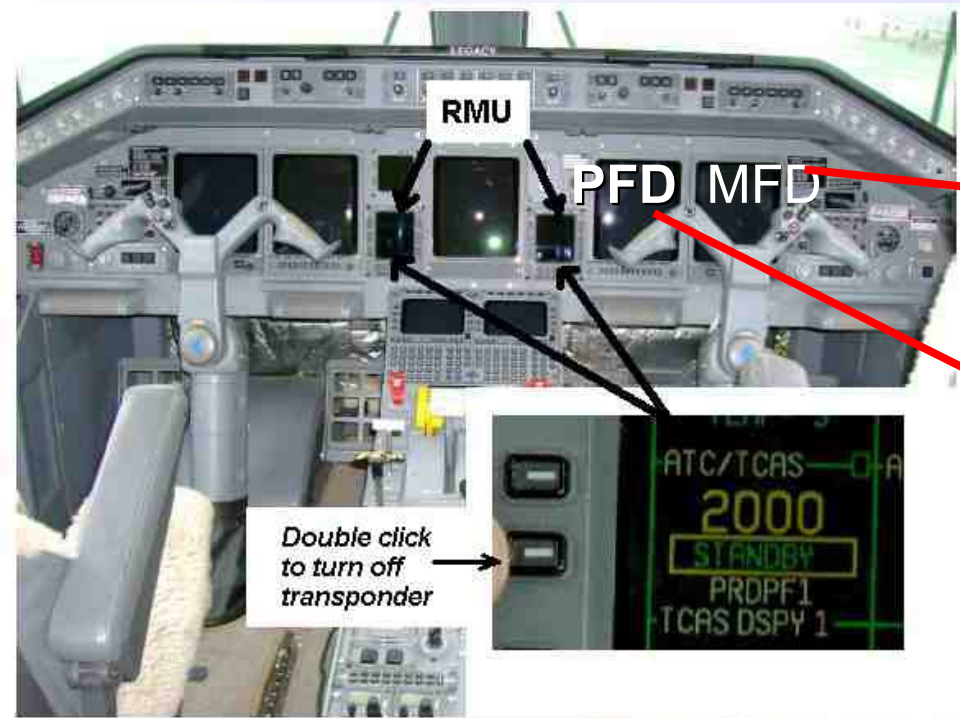
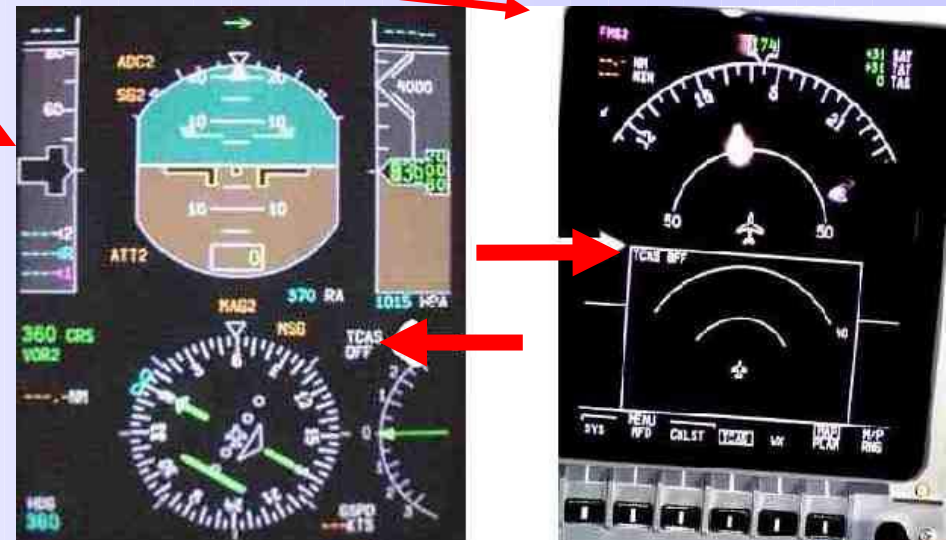
TCAS OFF - actuation and indications

“ (...) the ATC/TCAS standby mode is indicated on the RMU and Cockpit Displays (PFD/MFD), *however these indications may not be apparent to pilots*, especially during periods of high workload” (Irish Aviation Authority, 2005, pp 2).

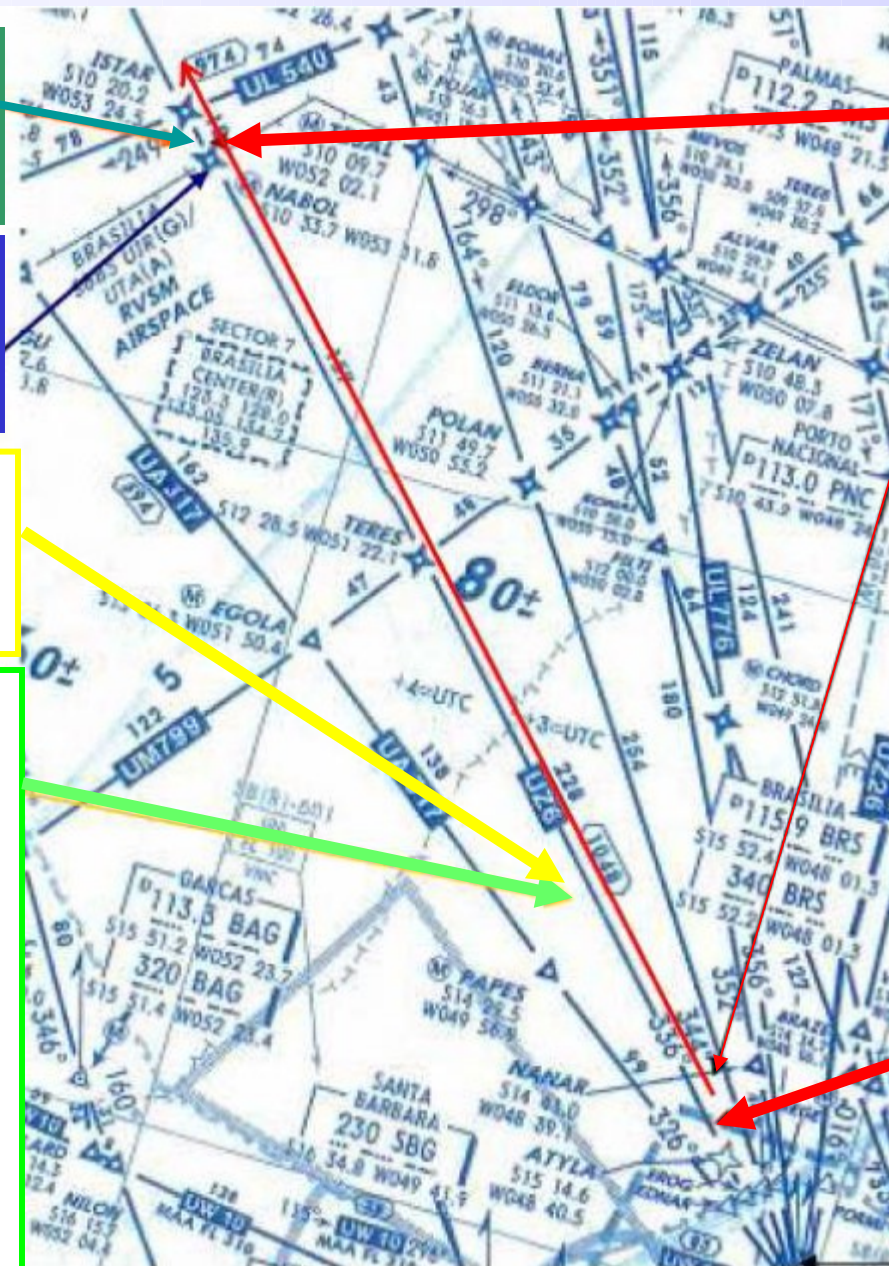
45 minutes
before collision
ATC had GLO
flight strip.

The N600XL
flight strip
was already in
the scope

Red line – ATC
radar was not
receiving Legacy's
transponder

Radar scope
updates every 10
sec. – 300 times
from the loss of
transponder signal
to the collision

19:02 - Loss of
transponder
signal

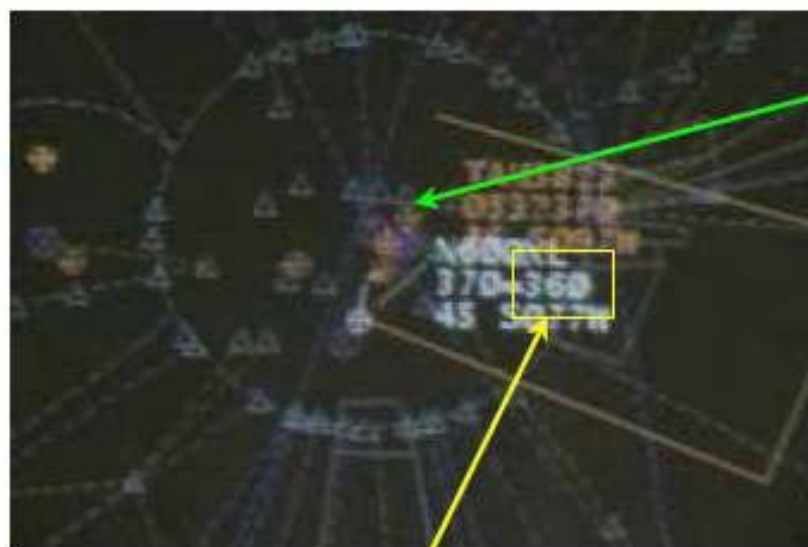
18:55Z: Prior to Brasilia, N600XL's Data Block Alerts Controller of a Planned Altitude Change

- Data block alerts controller that FL360 is ATC approved altitude after N600XL crosses Brasilia VOR.
- Mode C altitude shows **N600XL at its last assigned altitude of FL370**.
- Since the accident, it has been recommended that ATC software be modified to prevent the retention of flight plan altitude information in the data block because it frequently conflicts with the ATC altitude clearance, as it did here.

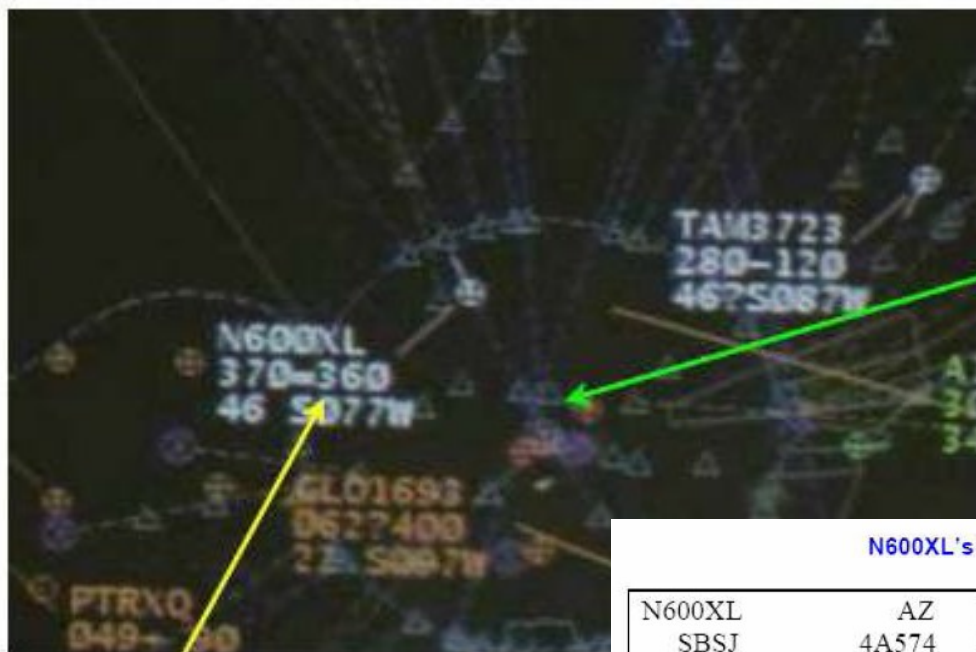
N600XL's Data Block After Passing Brasilia VOR

360 - planned flight level

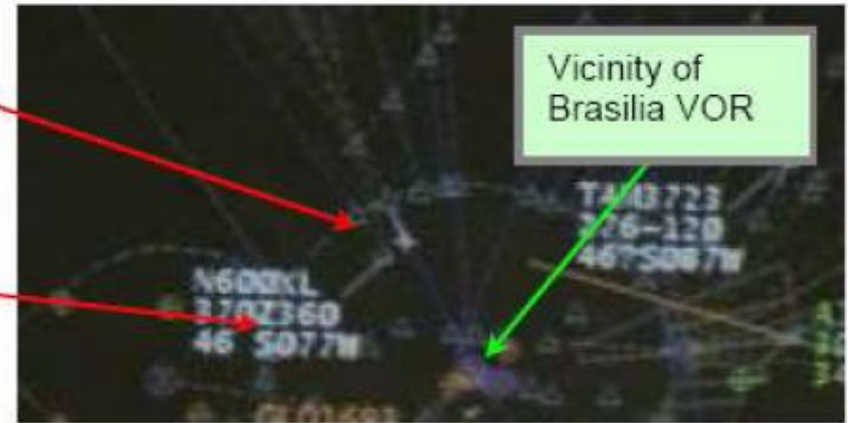
19:02Z: ATC Radar Scope Reveals Loss of the Legacy's Transponder

No transponder signal: Controller is required to initiate contact with N600XL, but fails to do so.

"Z" signifies that Height-Finding Radar (not more precise Mode C) is supplying altitude data.

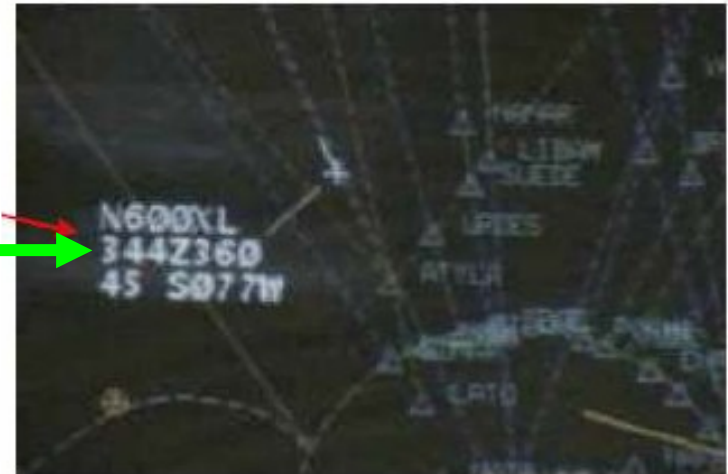
Sample of Estimated Altitudes Supplied by Height-Finding Radar After Loss of Transponder Signal at 19:02Z

radar estimating 33,400 ft.

FDR confirmed 37,000ft.

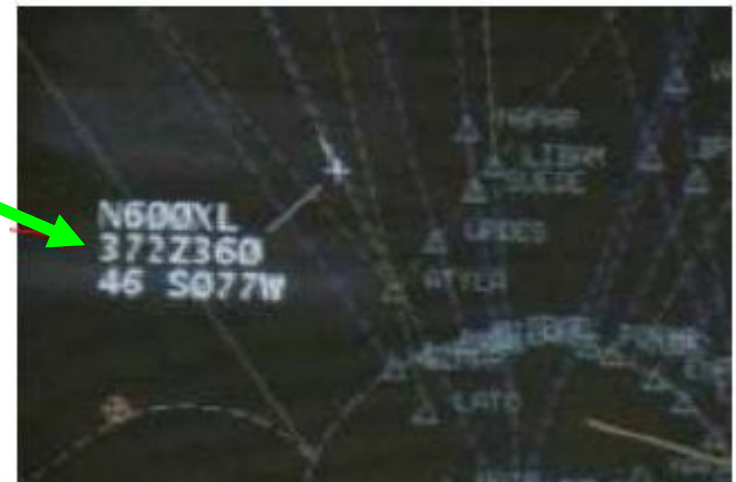
10 sec. later

radar estimating 37,200

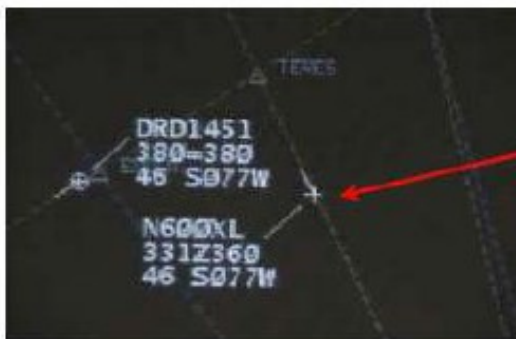
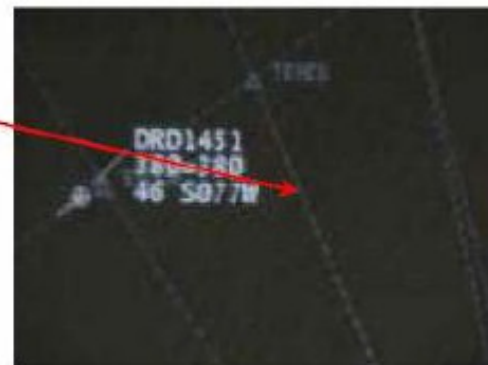
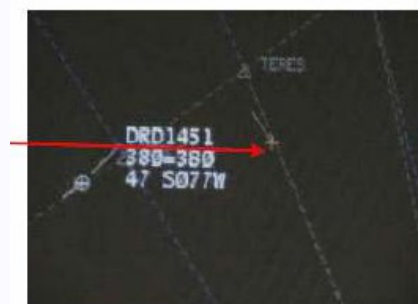
19:31Z: Radar Contact Lost with N600XL.
The Target Position Symbol and Data Block for the Legacy Disappear From Brasilia Center's Radar Scope in One Radar Sweep.

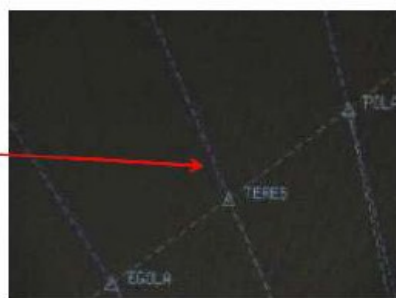
1934
N600XL appear
as an
unidentified
symbol

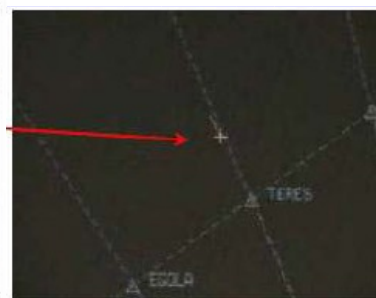
1938
N600XL
disappear
again

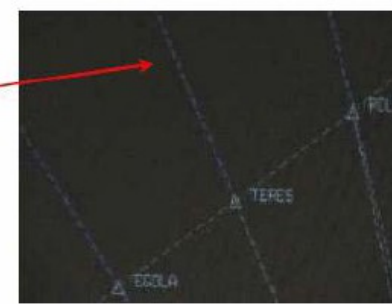
1940
N600XL
appear
again

1941
N600XL
disappear
from ACC
